\*\* KEHR'S MILL TRAIL UPPER DAM 5ST. LOUIS COUNTY, MISSOURI / 3 MO 11636

# 6 PHASE 1 INSPECTION REPORT NATIONAL DAM SAFETY PROGRAM

PREPARED BY: U.S. ARMY ENGINEER DISTRICT. ST. LOUIS

NOVEMBER 1980

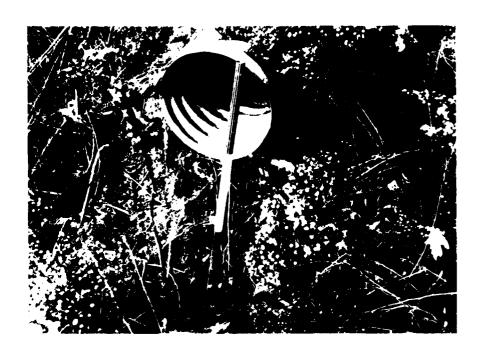
PHOTO 17: OUTLET OF DRAIN PIPE AT DOWNSTREAM TOE OF DAM

- (4) The two trees on the downstream face of the embankment should be removed.
- (5) Erosion protection on the embankment should be provided at the outlet of the drain pipe along the toe of the dam.
